A Pilot Study examining the Strength, Compressibility and Serviceability of Rendered Straw Bale Walls for Two Storey Load Bearing Construction.

Michael Faine and Dr. John Zhang
University of Western Sydney, Australia

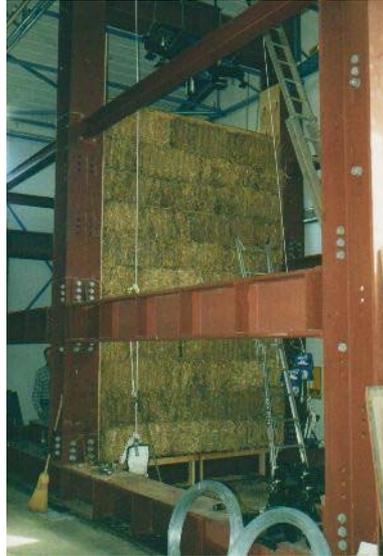
Figure 1 General view of steel test frame and partly completed wall (Photograph: P. Florence)

This picture shows the partly completed wall at the 8th course level contained within the steel reaction frame. A layer of 17mm thick structural plywood was added to this course and pinned to the bales. This was done to help stabilise the wall.

The University of Western Sydney has a well-equipped construction laboratory with a very large steel reaction frame originally developed for the testing of steel and steel/concrete composite columns under axial load up to 100 tonnes. This frame was used to contain the construction of the straw bale wall. Figure 1 shows the general frame arrangement with the partly completed straw bale wall framed between the large structural steel columns. The steel beams and columns were fabricated from 25mm thick steel, 400 x 400mm "I- beam" section, courtesy of a research grant and BHP steel sections.

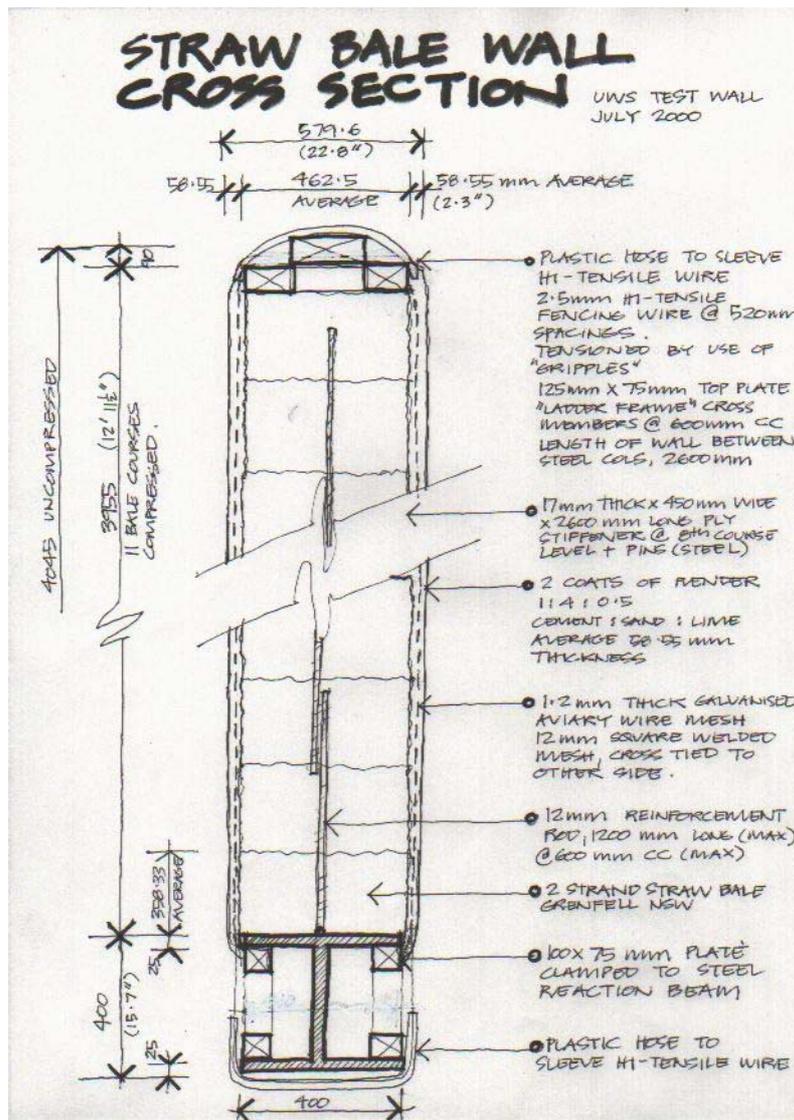
Figure 2. Straw Bale Wall Cross-Section. (Illustration M. Faine)

The wall was constructed to a height of 4045mm (uncompressed) being 11 courses in height; the length of the wall was 2600mm between steel columns with a layer of 17mm structural plywood placed against the steel columns to prevent the straw from expanding into the web of the columns. The general arrangement for construction can be seen in Figure 2. Bales were laid in stretcher bond pattern with a number of half bales. Bales were pinned over a 12mm reinforcement rod that had been tack weld to the frame. Pinning was continued up through the bales to the top course. The lower section of steel was assumed to simulate the concrete footing. A timber infill frame was constructed between the flanges of the bottom steel beam to allow for fixing of the wire mesh. Construction generally followed details reviewed from the literature and from interviews (Mitchell R.)¹²

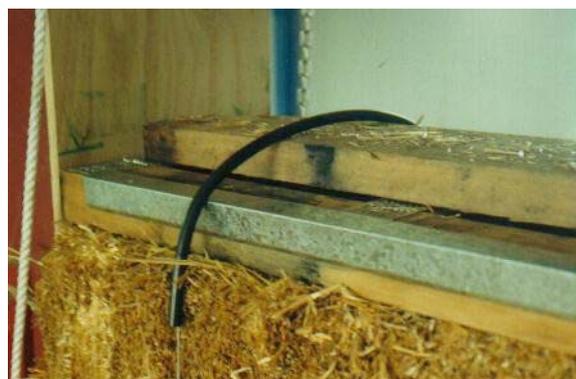
Figure 3: View of top plate assembly showing sleeved wire loop. (Photograph P. Florence)

The top plate was constructed from 125 x 75mm timber joined together as a ladder frame. An additional length was placed centrally to help distribute the load from the hydraulic rams. The high tensile fencing wire was run as a loop under the “footing” and carried up and over the top plate. A length of galvanised iron angle was placed at both top and bottom plates to provide for a radius turn for the wire to prevent a sharp edge from cutting the wire under load. This can be seen in Figure 3.

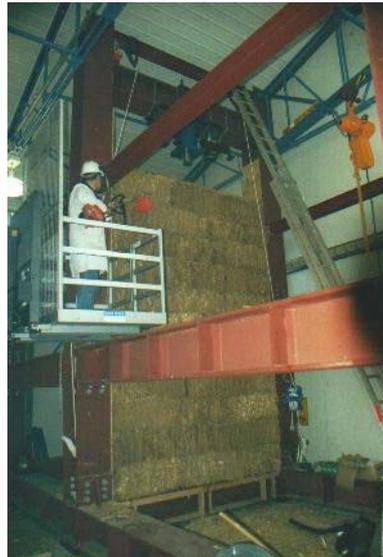
Figure 4: Trimming wall to size. (Photograph P. Florence)

The wall was trimmed to remove stray fibres and nocked into a reasonable straight line prior to the wall being compressed. Once the team was satisfied with the result the rendering process began. Two coats were applied over a period of two weeks, with the coats being applied in about a day and a half by a team of four (inexperienced) renderers. The mix design was 1: 4: 0.5 being cement: sand: lime. This was a strong mix with the addition of the lime to 'self heal' any later cracking. The rendering process can be seen in Figure 5.

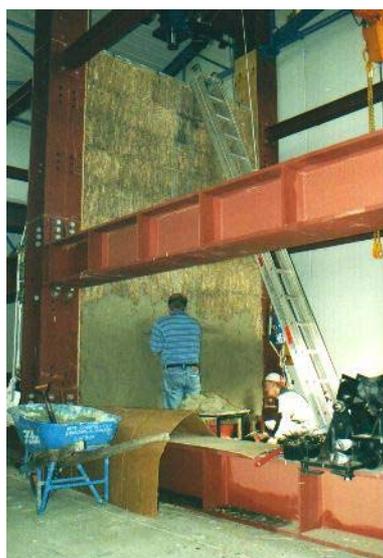
Figure 5: Render application over mesh and straw bales. (Photograph P. Florence)

This was a tedious part of the process and very labour intensive. Our research funds did not extend far enough to warrant using a spray application (this process alone would have accounted for approximately 25% of our funds). Render was applied to an average depth of approximately 60mm.

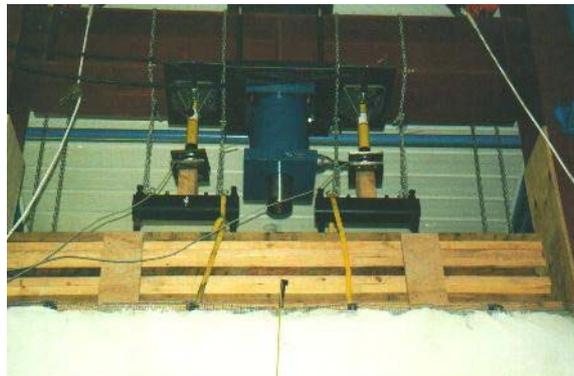
Figure 6: Hydraulic rams and top plate assembly. (Photograph P. Florence)

The test set up was fairly simple. Two 10 tonne capacity Enerpac hydraulic rams were coupled together and attached to the top steel reaction frame. 2 x 10 tonne load cells (HBM Agezelle) were placed in between the ram and steel spreader bars designed to distribute the load at 450 mm centres were stacked on top of the plate. The general arrangement can be seen in Figure 6.

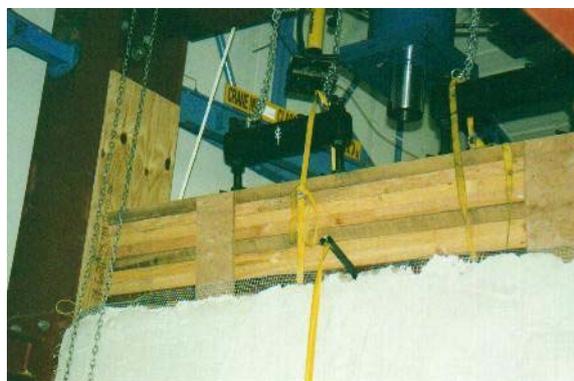
Figure 7: View of top plate, ram and measuring tape. (Photograph P. Florence)

The load cells were calibrated and the two electronic display units were set up to give a read out of the load from each hydraulic ram in newtons. During the test the readout from each unit would be noted against time and deflection/deformation of the wall. A steel scale had been attached to either side of the wall at the midpoint and this was to be read against a static point set up from the floor of the laboratory. Figure 7 shows the steel scale attached to the top plate and Figure 8 shows the other end of the tape and the data acquisition units.

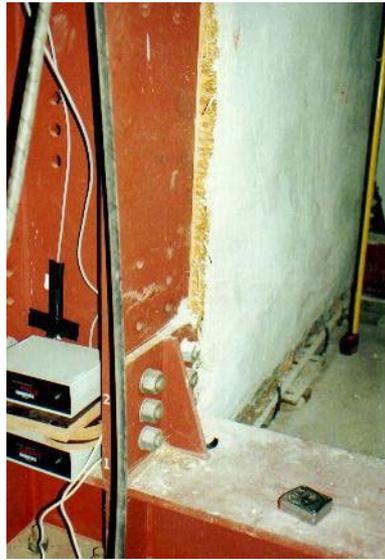
Figure 8: View of electronic display units and end of tape. (Photograph P. Florence)

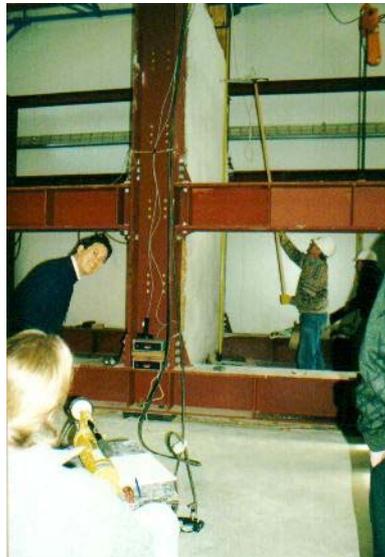
Two theodolites had also been set up to observe readings from pre-designated marked positions on the face of the walls to observe any lateral movement. Figure 9 shows how these measurements were to be taken and recorded as the loading progressed. These measurements were recorded to determine if the wall had moved sideways during the loading process.

Figure 9: View of lateral measurement process. (Photograph P. Love)

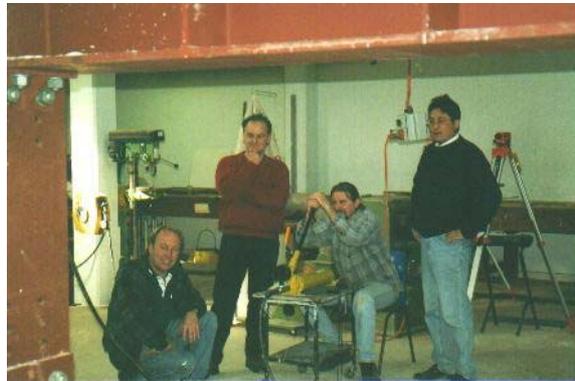
Figure 10 records some of the team members in action. The hand pump can be clearly seen with the theodolites set up in the background.

Figure 10: Some of the test crew in action. (Photograph P. Love)

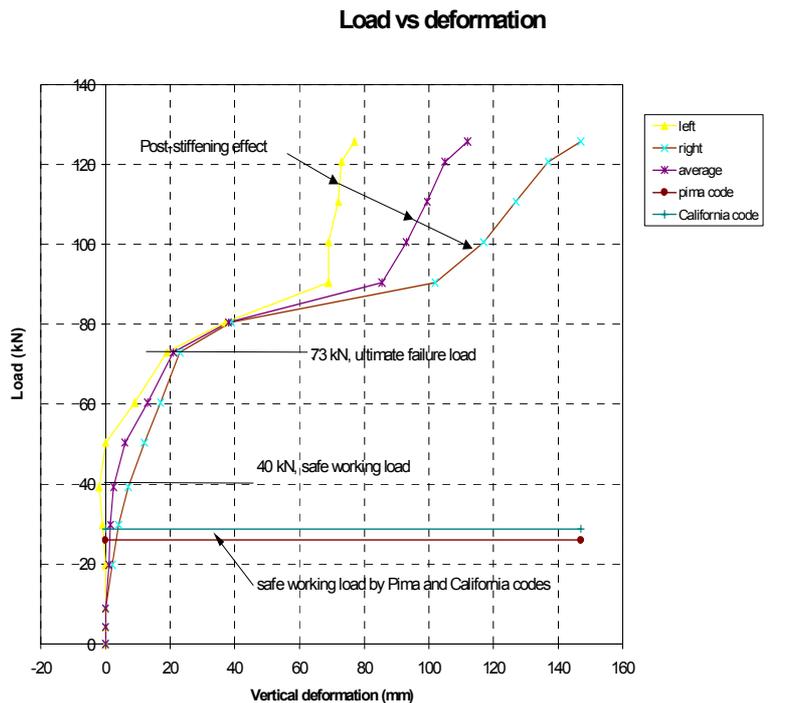
The results of this table have been shown in the following chart (Figure 13.)

Figure 13 Load Deformation Curve (Source J. Zhang)

The wall demonstrated some interesting and fascinating structural characteristics. Apart from the obvious failure region when the load reaches about 80 kN, it also reveals that the post-failure behaviour has a distinct feature of post-stiffening effect due to the compressibility of the material.

When the wall is first loaded, the behaviour follows a typical linear path. The left side deformation reading is negative indicating it is moving upward instead of downward as one would expect. This is due to the eccentricity in the applied load and in the wall itself. This eccentricity creates a significant bending effect so that the wall is bent toward the right hand side.

For this reason the average deformation between the left and right provide a more meaningful interpretation of the result. It can be seen on the average curve at the load level of just above 40 kN, there is a significant increase in deformation, demonstrated by the change of slope in the curve. One would stipulate that due to the compression of straw bale, the interaction between the straw and the cement render becomes less significant resulting in the 'softening' of the wall. As the load increases the wall starts to 'yield'. At the load level of 70 kN there is a significant increase in deformation, which marks the failure of the wall. This failure is probably due to the significant separation between the straw bale and the cement render. As the load increases further, the straw bale becomes fully compressed, therefore becoming more solid as the load starts to increase further. Although this post-failure capacity cannot be used in the design of straw bale wall, it does illustrate that the post-failure behaviour is rather stable.

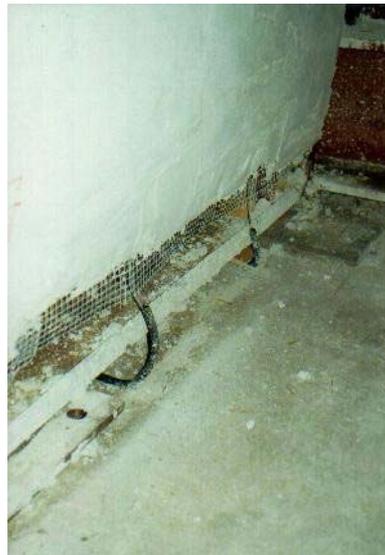
Figure 14. View of bottom plate after test (Photograph P. Florence)

The wall did not fail as expected; most of the team were anticipating that the wall would buckle under load with parts of the render falling away from the face of the wall. In fact very little cracking was observed to have formed in the face of the wall. Both faces of render had acted like a 'curtain' and followed the compression of the wall. This can be clearly seen in Figure 14, a view of the bottom plate of the wall. The high tensile wire loop has become slack and has fallen as the wall had compressed, the render has stayed remarkably intact on both faces.

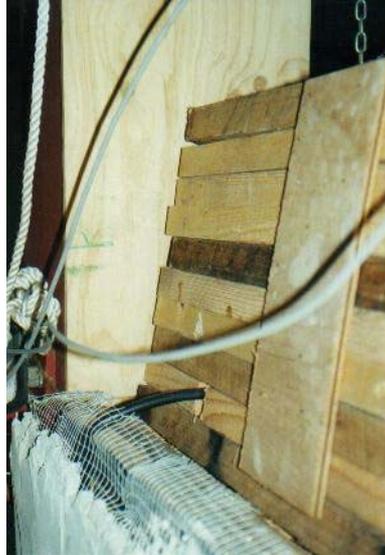
Figure 15. View of top plate after the test. (Photograph P. Florence)

The top plate had twisted progressively under load and possibly would have ‘tumbled over’ if the test had been continued.

The top plate was also observed to have rotated during the test. It is possible that the load was slightly off centre or that the straw was less stiff on one side. Another possibility could be that

the wall was not perfectly plumb and square when constructed but was within reasonable limits for a bale wall. Figure 15 records a view of the top plate after the test.
